## Timbercreek Canyon Property Owners Association Board Meeting

## TCPOA Road Report for Meeting 10-6-2020

## **Culvert Project Pictures 6-2-2020**

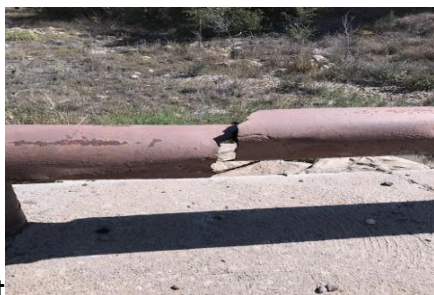
There is a separation in the guardrail on the dam. It may have been struck by a vehicle or separated due to being a thin rusted pipe or both. A section needs to be cut out and replaced with newer pipe.

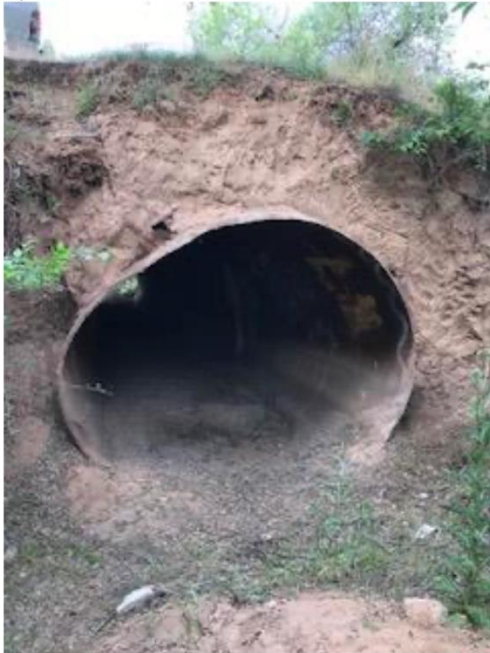
Upstream Entrance

This structure may be between 40 and 50 years of age and I suspect that some of procured materials were used oilfield tanks. The first two sections appear to be tanks laid on their side and have a poor fit. Concrete was used to fill in the gaps. Some of the gaps are not filled and soil can be seen through the cracks. The second section appears to be deformed from its original form. Rust abounds inside this structure which calls into question the integrity of the metal.

Larry Naiman and I recently spoke to Joe Shehan with JSE about the progress of the Culvert project. JSE has inspected the structure and has also determined the drainage area involved and completed calculations to determine the proper sizing of a replacement culvert. The current size of the culvert is approximately 10 feet but the calculations show we only need a 4.5 foot corrugated metal pipe (CMP) to handle a 100 year storm event (1% chance). The new 4.5 foot CMP would be placed inside the current structure then headwalls would be placed around the new pipe and then a flow fill material would be pumped into the void between the two pipes. At this point a topographical study will need to be performed on both sides of the culvert in order to design the headwalls. The topographical study would cost \$1,500 and the headwall design would cost \$2,500. By spending \$1,500 for the topo and the first \$1,000 of the headwall design (\$2,500) would put us in a position to get solid estimates for the costs of construction. Although no metallurgy tests were run to evaluate the existing metal structure, it is estimated that we have 5-6 years to replace the current culvert.

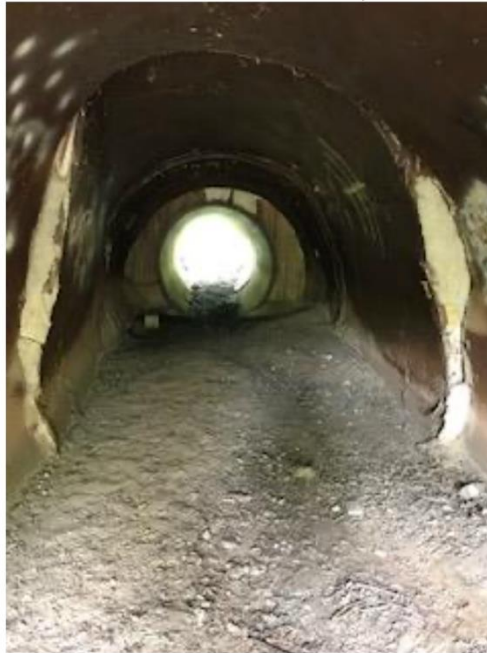
Three Piece Structure: Tank-Tank-Pipe

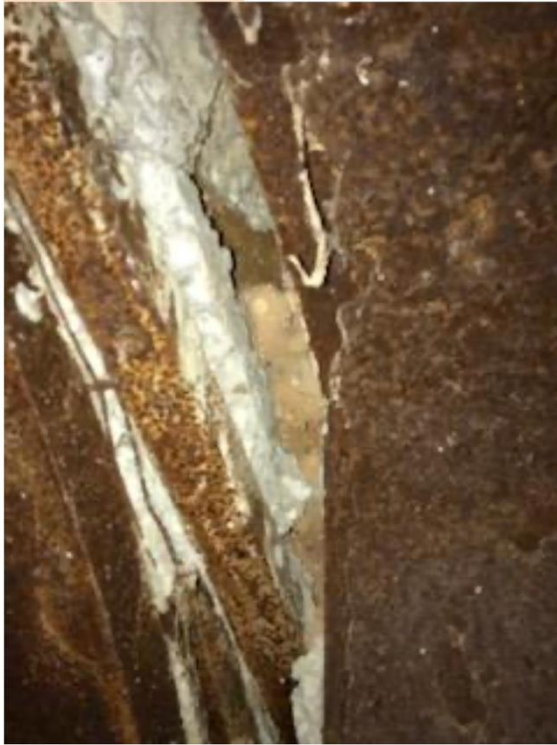
Seam Between Tanks

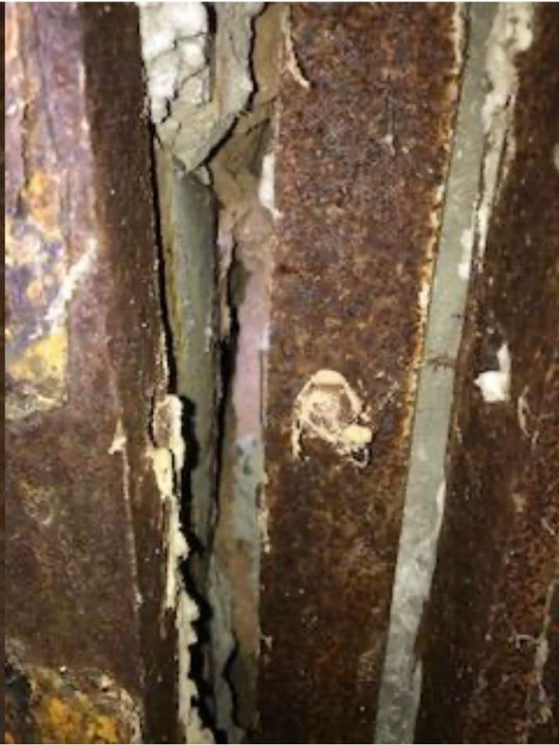
Seam Between Tanks

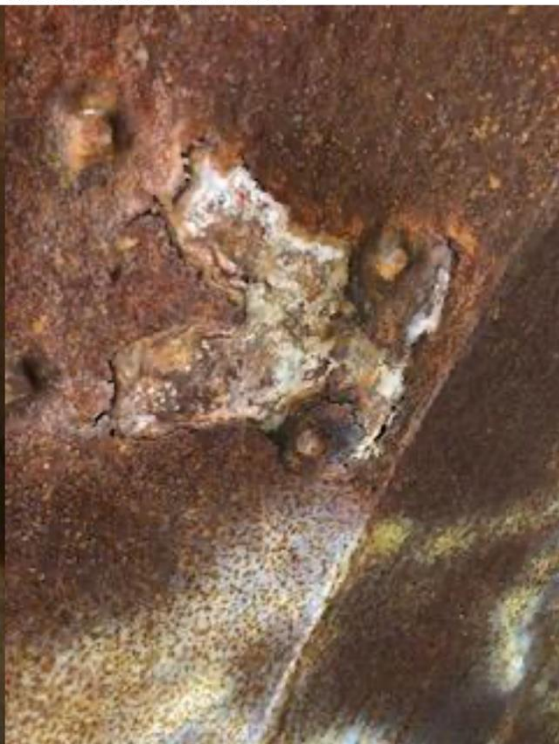
Rust In Numerous Places
